# PHASE I INSPECTION REPORT

## NATIONAL DAM SAFETY PROGRAM

COLEMAN FALLS DAM  
AMHERST COUNTY, VIRGINIA  
INVENTORY NO. 05918

Name of Dam: Coleman Falls  
Location: Amherst County, Virginia  
Inventory Number: VA 00903

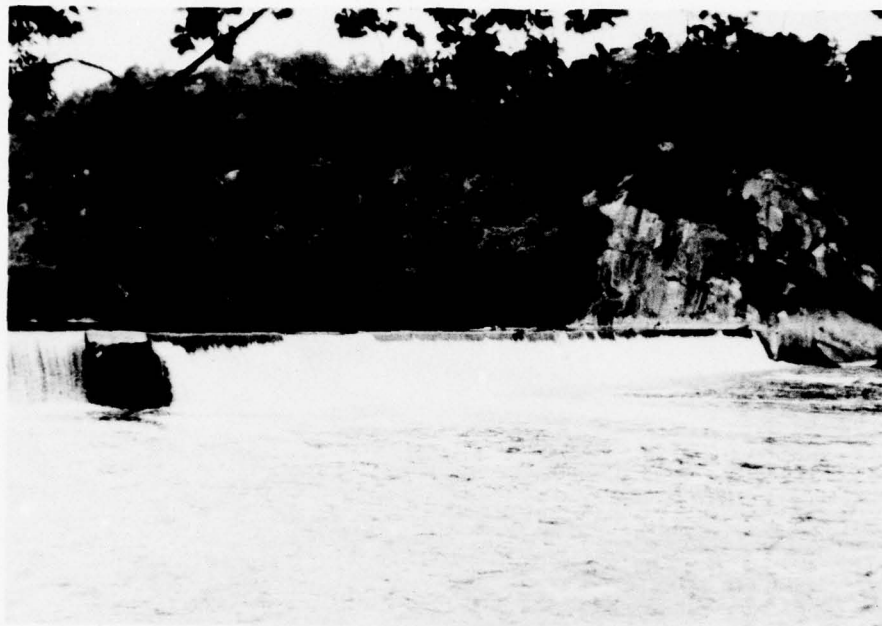
PHOTOGRAPH NO. 1  
Spillway

3.1.4 Spillway: The Spillway is a masonry structure and appears to be in good condition except as noted in 3.1.2 above.

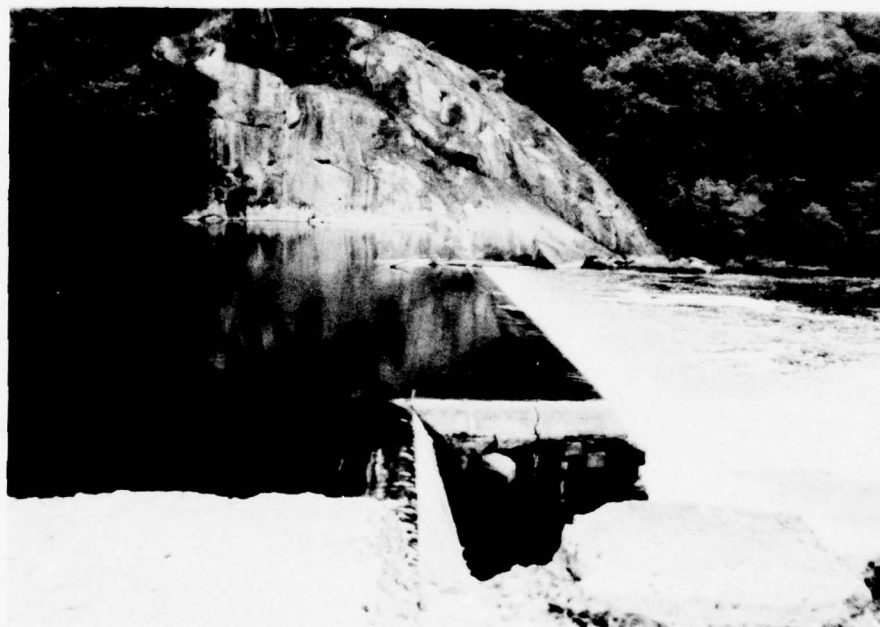
PHOTOGRAPH NO. 2  
Left Abutment

3.1.2 Dam: The dam appears to be in good condition. A crack and several missing stones were noticed in the dam about 65 feet from the remains of the turbine building where the dam makes a 90° turn. The seepage through this crack is significant (approximately 5 gpm), however, due to its inaccessibility no measurement of flow was made (see Photograph No. 2, Appendix II.)

VISUAL EXAMINATION OF	OBSERVATIONS	REMARKS OR RECOMMENDATIONS
SEEPAGE OR LEAKAGE	Seepage at corner where rocks are missing. , 65 feet from right abutment.	
STRUCTURE TO ABUTMENT/EMBANKMENT JUNCTIONS	No apparent misalignment.	
DRAINS	N/A	
WATER PASSAGES		
FOUNDATION	Unknown.

VISUAL EXAMINATION OF	OBSERVATIONS	REMARKS OR RECOMMENDATIONS
SURFACE CRACKS CONCRETE SURFACES	Some of the stone had been knocked off the crest of the dam and there was deterioration of the masonry at the corner formed by the dogleg in the dam at the right end.	
STRUCTURAL CRACKING	No serious cracking.	
VERTICAL AND HORIZONTAL ALIGNMENT	No misalignment	
MONOLITH JOINTS	N/A	
CONSTRUCTION JOINTS	N/A

3.2 Evaluation: The dam appears to be in good condition with the notable exception of the crack and missing stones in the spillway. It is recommended that the owner monitor the leakage as part of his regular maintenance program and prior to converting the dam for hydroelectric use, the owner should initiate a more thorough inspection to insure that no other significant deterioration has occurred.

**7.2 Recommended Remedial Measures:** The inspection revealed some seepage and missing rocks which should be monitored as part of the regular maintenance program. It is recommended that the owner perform a more detailed inspection to insure that no other significant deficiencies exist before converting the dam to hydroelectric use.

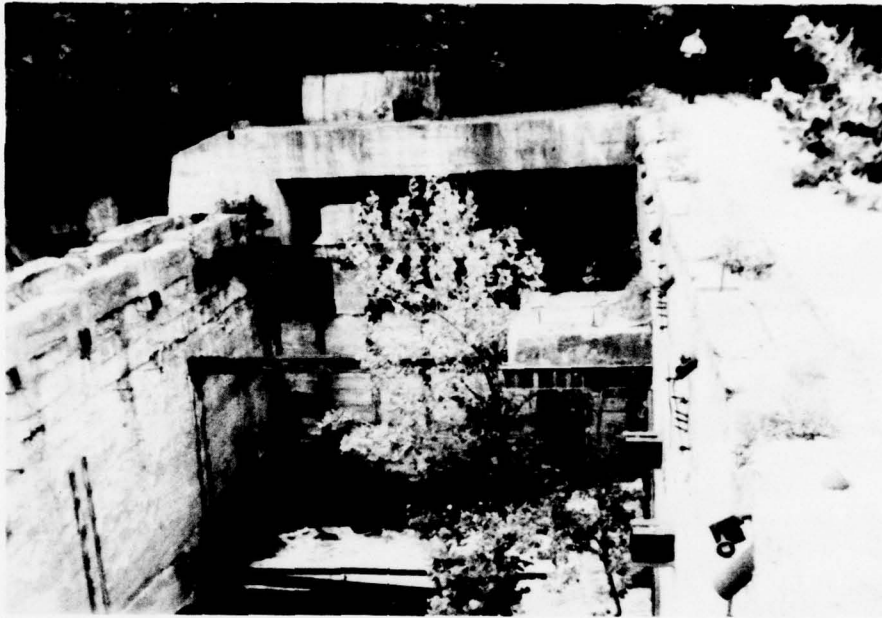
PHOTOGRAPH NO. 3  
Old Mill Structure

3.1.3 Appurtenant Structures: The remains of the old turbine building are located adjacent to the right abutment. Water is seeping through the headgate openings into the turbine pits, however, there is no apparent seepage around the dam near the building. There is no means, at present, of operating these gates.

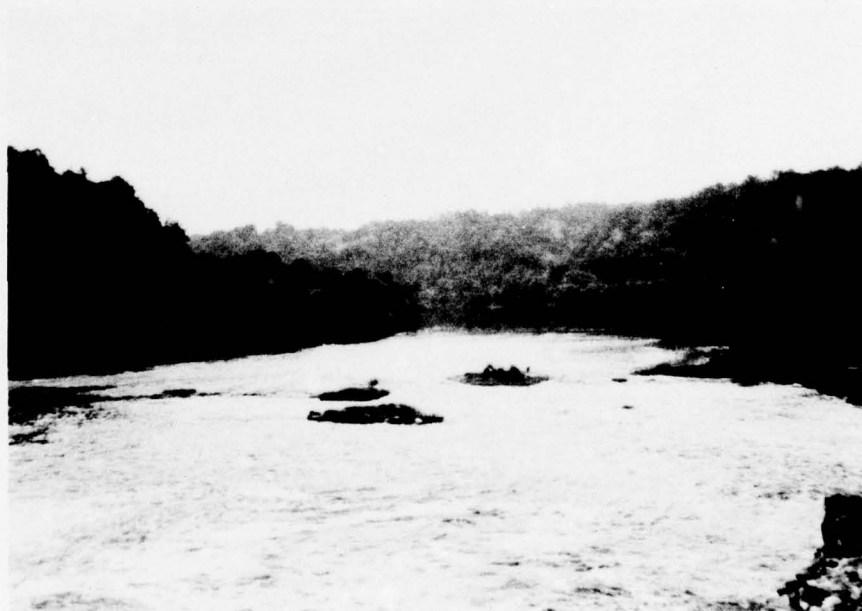
PHOTOGRAPH NO. 6  
Downstream

3.1.7 Downstream channel: The downstream channel is the natural riverbed. The banks are wooded with steep slopes.
